Membrane Treatment

Biological Monitoring Improves Membrane Performance

A southern US water treatment facility used advanced ATP testing for biological monitoring to improve membrane filtration operations and product water quality. **BY BILL TRAVIS AND DAVE TRACEY**

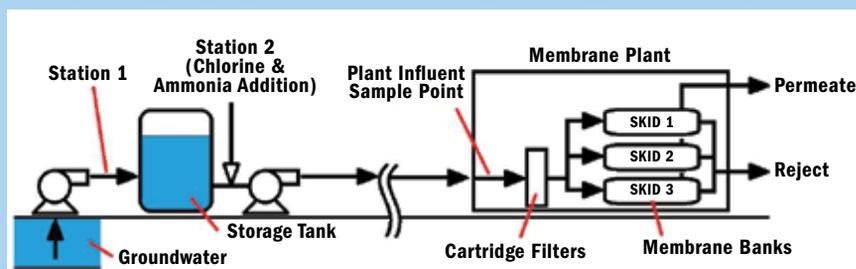
Figure 1. Groundwater Treatment Process Flow Diagram

The Louisiana plant performed well initially, but prefilters and membranes soon became severely fouled, prompting the use of ATP monitoring technology to assess the problem.

significant biological fouling of the membranes ensued. Figure 1 shows a process flow diagram of the plant. Proactive biological monitoring using advanced adenosine triphosphate (ATP) was able to guide mitigation activities and optimize several design modifications to improve plant operation and product water quality.

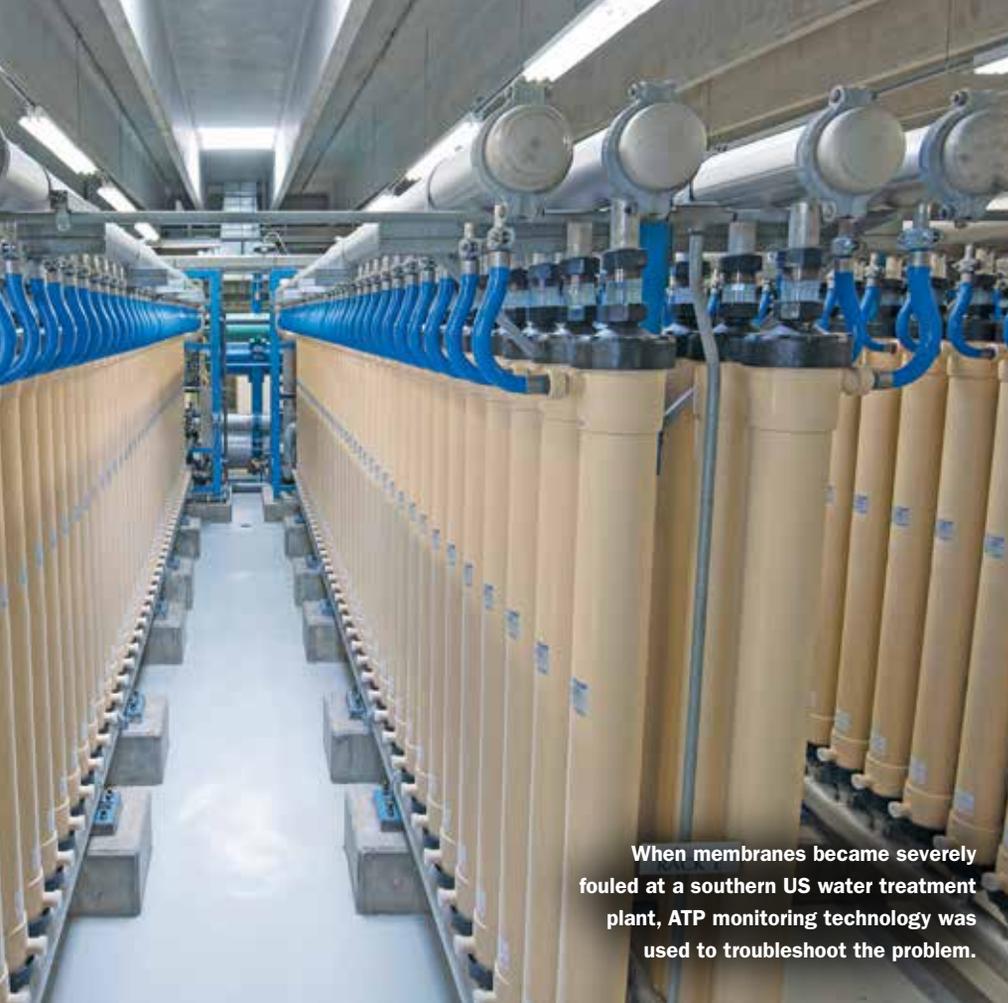
When membranes became severely fouled at a southern US water treatment plant, ATP monitoring technology was used to troubleshoot the problem.

in which DBP formation was reduced while still cutting down the organics loading and color in the raw water. While the reduced chlorination prior to membrane filtration resulted in less DBP formation than in the past, the microbial loading at the plant inlet became significantly higher as seen in Figure 2. Permeate quality temporarily remained acceptable, but the plant was shut down after an additional week under these conditions because of excessively high pressure differentials across the membranes.

After three weeks of running under these new conditions, another set of samples were collected and analyzed, as shown in Figure 2. The cleanliness of the product water had risen slightly, but the overall picture was significantly better than when the membranes had become fouled earlier in the summer. The plant's strategy was then to perform semi-routine tests on the water downstream of the prefilters and on the combined membrane product water to detect deviations from baseline conditions and allow a more proactive stance to be taken.

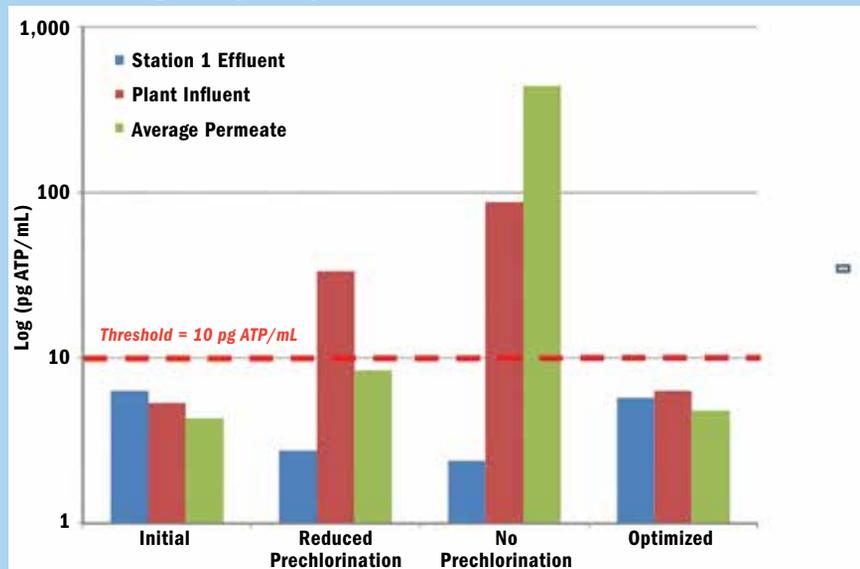
Figure 2. Summary of Results With Each Control Scheme

Several changes were made in the operating procedure after the cleaning process to minimize fouling of the plant's prefilters and membranes.

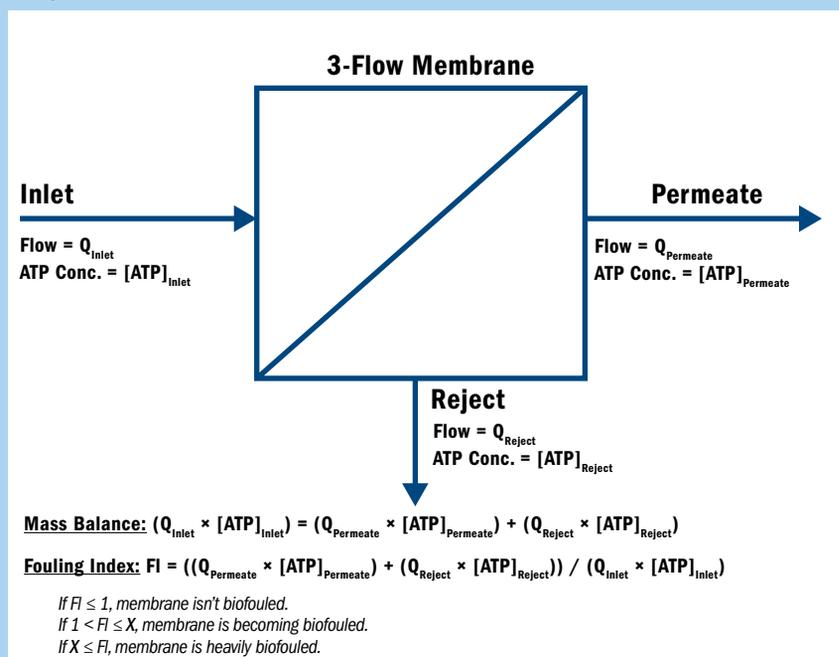
Figure 3. Membrane Fouling Concept

The plant used flow rates and ATP concentrations around each membrane.

Following the modifications made in the spring of 2012, the plant continued to run much more effectively than under previous conditions, but other opportunities for improvement became apparent. This was determined by establishing a monitoring strategy involving a mass balance model using flow rates and ATP concentrations around each membrane. Essentially, ATP load in must be approximately equal to that which exits. If more ATP exits than what enters, it indicates a fouled membrane in which biological growth and breakthrough occurs. Figure 3 shows this concept.

By comparing the membrane-bioburden level to the sum of permeate and reject-bioburden levels, internal biofouling can be assessed. If the bioburden out is greater

than that which enters, the result immediately indicates that growth is occurring within the membrane, thereby initiating preventive maintenance. This operational strategy maximizes membrane life while optimizing produced water quality and overall process efficiency.

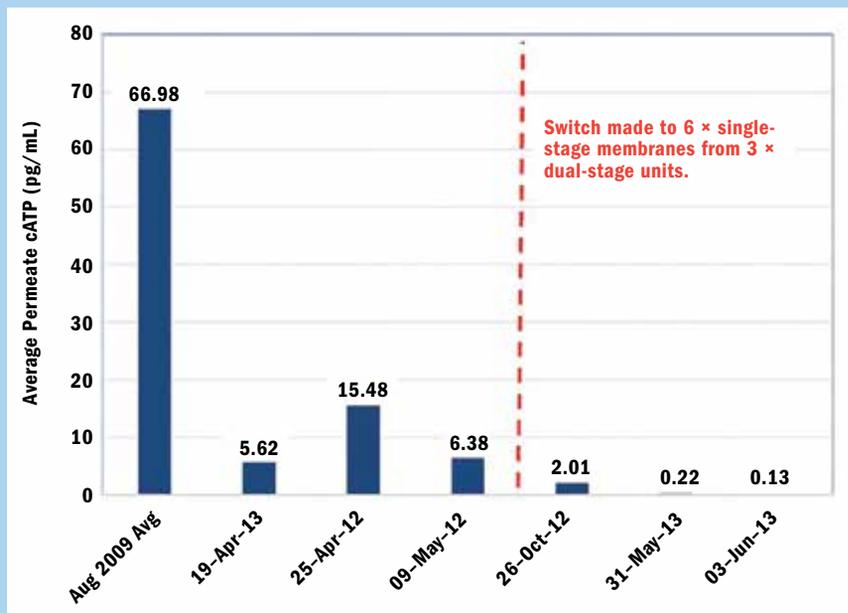
Figure 5. Final Product Water Quality

Reduced fouling in the membranes, achieved by switching to six single-stage membranes, significantly improved water quality.

The results in Figure 4 show that spreading the membrane feed stream over six parallel units eases the burden on each one and results in reduced fouling tendencies and improved filtered water purity, as shown in Figure 5, which quickly became apparent after the switch and has gotten better over time. Also, plant electricity usage dropped significantly as a result of reduced pumping back pressure, exceeding \$1,000 a month since the switch.
